Interactive Troubleshooting Guide for Frequently Seen Issues

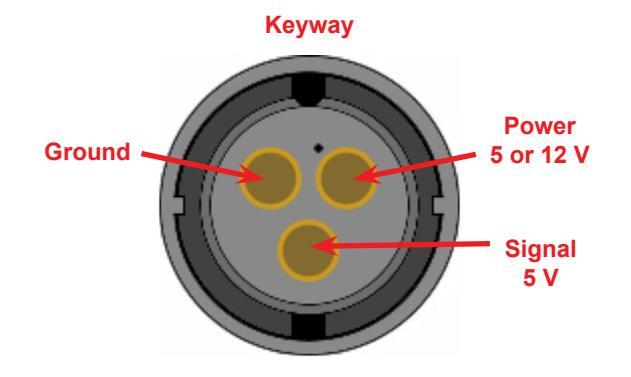
While moving, verify on the console that the distance is counting up and that speed is present.
Is the speed source mounted correctly?
Does it have adequate power?
Verify voltages as seen in the image below.
Is the Speed Type set correctly?
SP1 - Wheel
SP2 - Radar, or Simulated Radar from GPS
Is the Speed Cal number correct?

Speed Sensor Test

- 1. Enter a Speed Cal of 1000 (SP1) or 9999 (SP2).
- 2. Watch the distance on the console.
- 3. Start at the speed source. With a small jumper wire (or paper clip), short between Ground and Signal with a "short-no short" motion. Each time a contact is made, the distance should increase.
 - If distance does not increase, remove the section of cable and repeat the test at the next connector toward the console. Continue on until you find a bad cable or until you reach the back of the monitor. Replace any bad cables as required.
 - If all cable tests pass then there is a problem with the speed source. Replace the speed source.

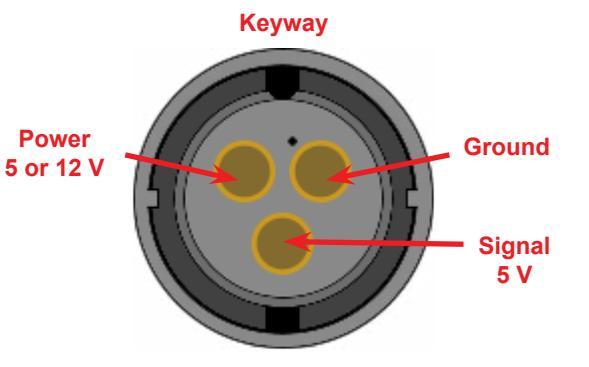
Verify voltages as seen in the image below.

Flow Meter / Encoder Test

- 1. Enter a Meter Cal of 1 if doing liquid, or a Density of 1 and a Spreader Constant of 0 if doing granular.
- 2. Place the system in Manual if using an SCS console.
- 3. Zero out the total volume on the console.
- 4. Turn at least one boom section to the "ON" position as well as the master switch.
 - Try multiple boom switches in case there is a faulty hardware switch connection.
- 5. With a small jumper wire (or paper clip), short between Ground and Signal with a "short-no short" motion. Each time a contact is made, the total volume should increase by increments of 1 or more.
 - If the total volume does not increase, remove the section of cable and repeat the test at the next connector toward the console. Replace defective cable as required and recheck.
 - If all cable tests pass then there is a problem with the flow meter / encoder. Replace the flow meter / encoder.

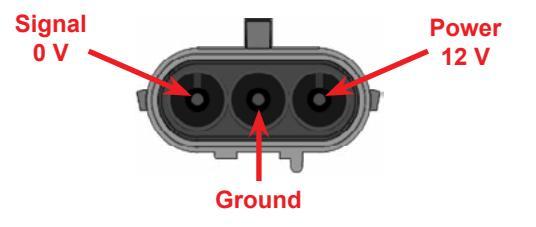
1. Check Voltage at the Fan RPM Sensor Connector

If voltages are present on the console cable and any extension cables but not on the 3-pin connector then the product cable is bad and needs to be replaced. If voltages are present on the console cable but not on any extension cables then the extension cable is bad and needs to be replaced.

If voltages are not present at the console cable connection then the console / console cable is bad and needs to be replaced.

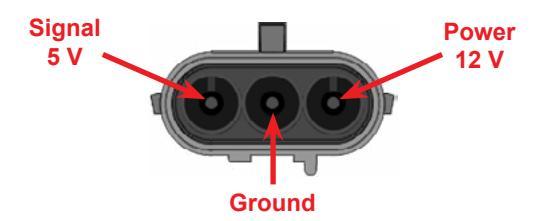
1. Check Voltage at the Fan RPM Sensor Connector

If voltages are present at the node but not on the 3-pin connector then the spinner control cable or product controller cable is bad and needs to be replaced.

If voltages are not present at either the 3-pin connector or the node connection then the node is bad (assuming the first product is functioning properly for a dual product node) and needs to be replaced.

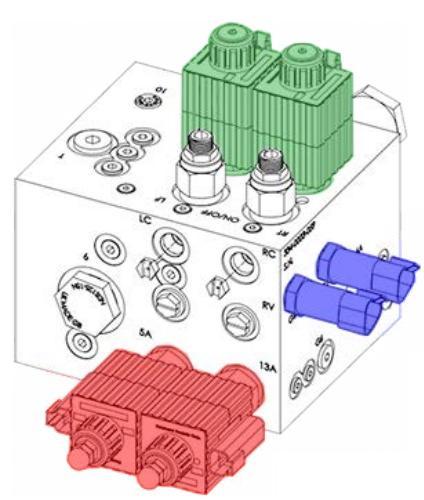
Old Hydraulic Block

Proportional Valves

Pressure Transducers

Blockers

Verify that the electrical connections are connected correctly. The 2-pin Deutsch connectors labeled "Solenoid" connect to the blockers. The "Prop" connectors connect to the proportional valves.

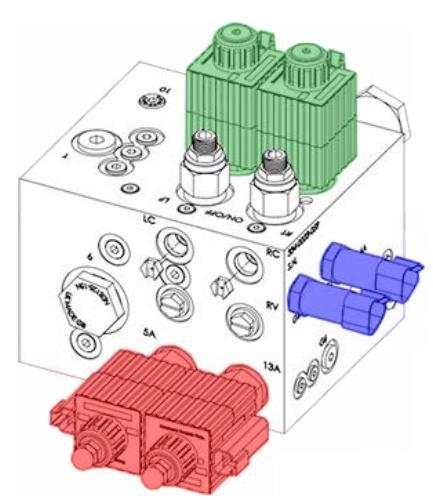
Old Hydraulic Block

Proportional Valves
Pressure Transducers

Blockers

Verify that the hydraulics are connected and working correctly. This can be done directly from the AutoBoom hydraulic valve block.
